Resurrection Creek Stream and Riparian Restoration Project

Stream Channel and Vegetation Monitoring Report, 2005 through 2008

USDA Forest Service Chugach National Forest

January 2009

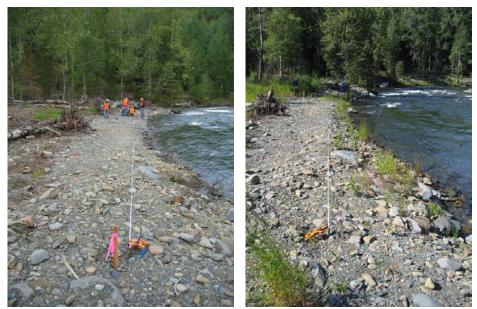
**Figure 3.18:** Bare soil plus course fragments dominate Transect 3 in both 2006 on the left photo (95% cover) and 2008 on the right photo (97%). No plant species has  $\geq 5\%$  average cover along the transect in either year. Note: the quadrat frames are "read" along the left side of transect. Vegetation along the stream edge includes plantings by the Youth Restoration Corps. It is anticipated that cover from these plantings will eventually cross the line of the transect.

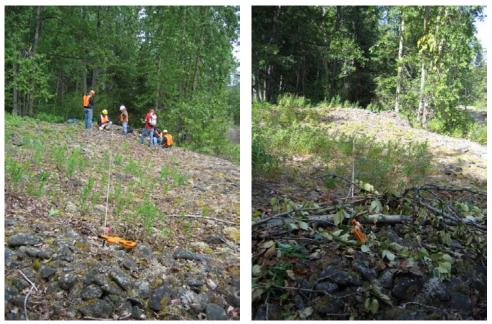
**Figure 3.19:** Transect 4 is the "control" on a historic mine tailing. Vascular plant cover is low in both 2006 on the left photo and 2008 on the right photo (8 and 15%, respectively). The most visible plant along the transect in the two photos is tall fireweed (*Epilobium angustifolium*). Perhaps the largest change is that a black cottonwood (*Populus balsamifera* ssp. *trichocarpa*) had fallen across the transect in 2008 (visible in photo).

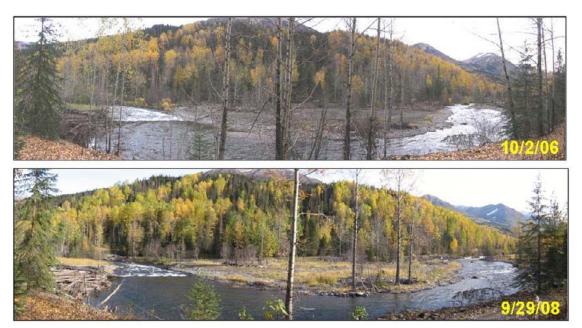
**Figure 4.2**: Resurrection Creek Photo Point 3 (panorama). This shows the point bar of Meander 3. In the two years since project completion, abundant vegetation has grown on the floodplain, and beavers have removed several cottonwood trees along the trail. Sediment deposition has occurred on the point bar (center of photo), and additional trees have lodged into the logiam (lower left of photo).

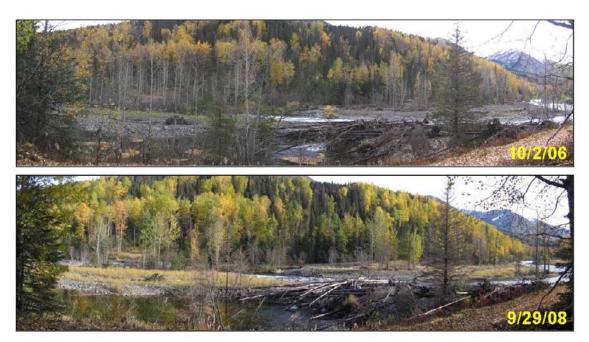
**Figure 4.3**: Resurrection Creek Photo Point 4 (panorama). This shows the western side channel and pond between Meander 2 and Meander 3. Abundant vegetation has grown on the floodplain. Little or no change has occurred on the logjam (right side of photo) or side channel (foreground).

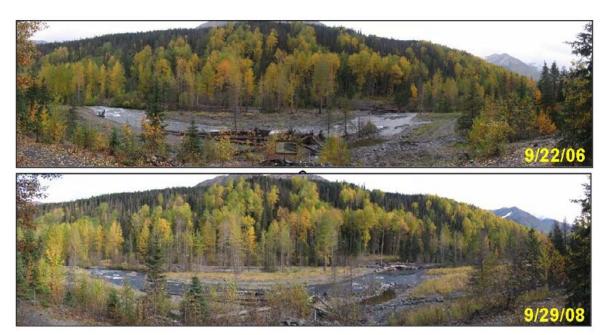
**Figure 4.4**: Resurrection Creek Photo Point 5 (panorama), showing Meander 2. Abundant vegetation has grown on the floodplains from both re-vegetation and natural regeneration. Spruce trees in the lower right of the photo have died.

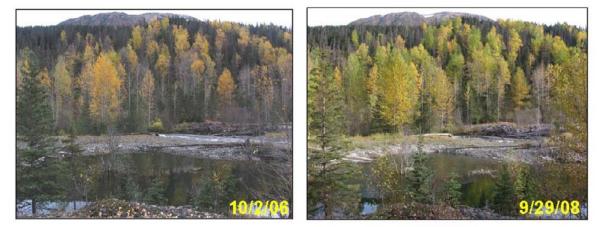
**Figure 4.5**: Resurrection Creek Photo Point 6b. This shows the west side channel pond of Meander 2. The water surface elevation of the pond varies with flow because the pond drains through the substrate of the outlet (both of these photos were taken at low flow). Abundant vegetation has grown on the floodplains from both re-vegetation and natural regeneration.

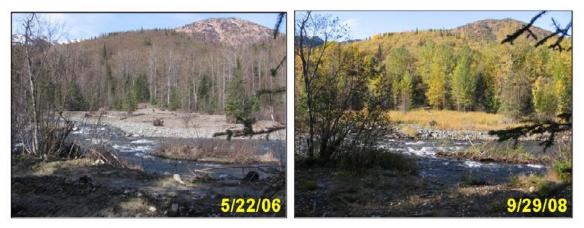
**Figure 4.9**: Resurrection Creek Photo Point 14a. This shows the western floodplain of Meander 4. Because good soil was spread on this floodplain, abundant vegetation has become established in 2 years through natural regeneration. Few channel changes have occurred following completion of the restoration.

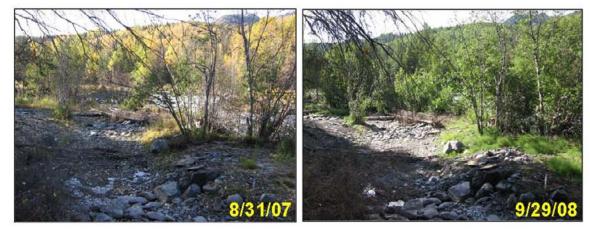
**Figure 4.10**: Resurrection Creek Photo Point 14b. This shows the lower Meander 4 east side channel. Few changes have occurred to this channel, but sparse re-vegetation has occurred. The channel runs dry during low flows (as shown in both photos) because water seeps through the substrate from the pond upstream back into the main channel of Resurrection Creek.

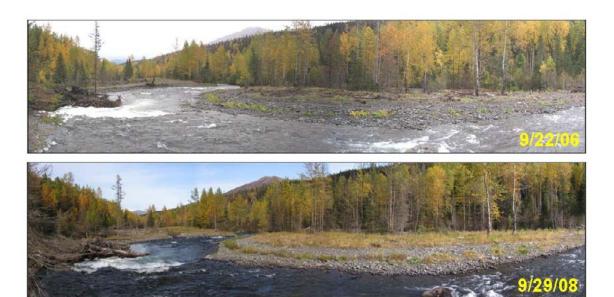
**Figure 4.11**: Resurrection Creek Photo Point 15a (panorama). This shows the Meander 2 riffle, logjam, and eastern floodplain. Abundant re-vegetation has occurred on the floodplain, including a row of planted willow stakes along the bank. However, soil was not spread far enough to the bank following restoration, leaving a strip of un-vegetated gravel. The steep riffle upstream of the logjam may be headcutting upstream, but this is not yet evident in the photos.

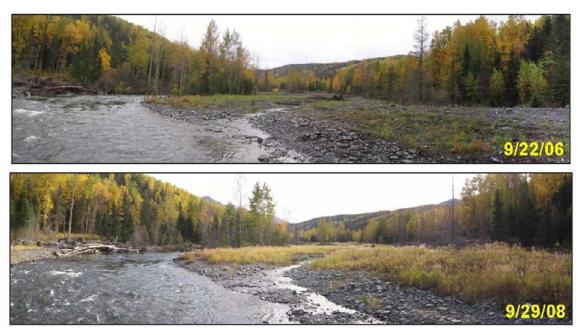
**Figure 4.12**: Resurrection Creek Photo Point 15b (panorama). This shows the western floodplain between Meander 2 and Meander 3. Abundant vegetation has grown as a result of the natural soils placed on the floodplain. The "meander scar" side channel in the center of the photo carries perennial flow from groundwater.

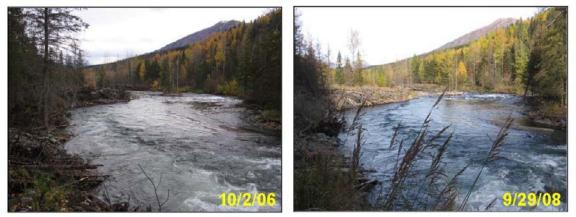
**Figure 4.14**: Resurrection Creek Photo Point 17a. This shows the Meander 4 pool. Deposition of fine gravels has occurred in the slack water on the right side of the pool.

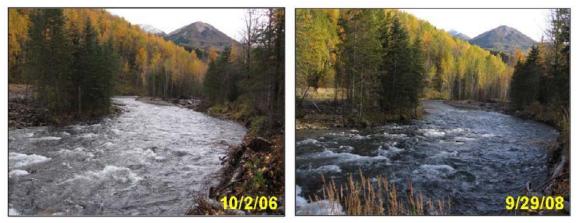
**Figure 4.15**: Resurrection Creek Photo Point 17b. This shows the Meander 4 riffle. Few channel changes have occurred.

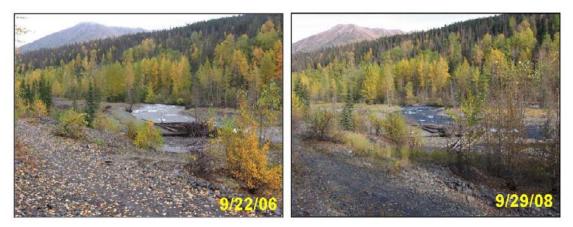
**Figure 4.17**: Resurrection Creek Photo Point 20. This shows Meander 2. Few major channel changes are evident in this photo.

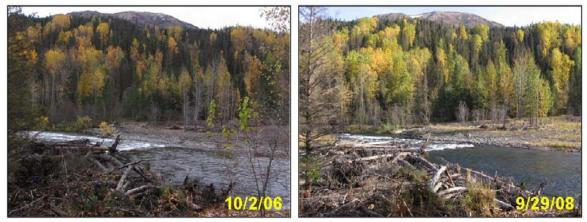
**Figure 4.19**: Resurrection Creek Photo Point 22, showing the lower Meander 3 riffle and logiam. Few channel changes have occurred in this riffle.

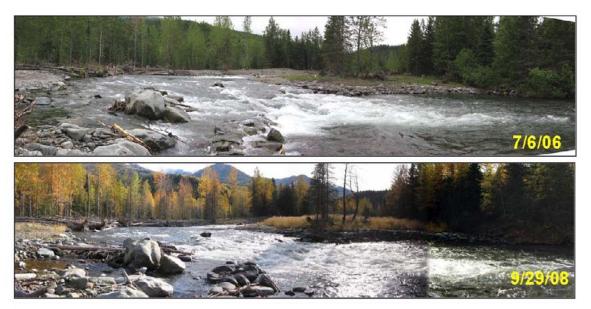
**Figure 4.21**: Resurrection Creek Photo Point 25 (panorama), showing the lower riffle of Meander 5. Although this riffle is one of the steepest in the project reach, no headcutting is evident in the 2 years since project completion. However, the riffle has adjusted to a more uniform slope.

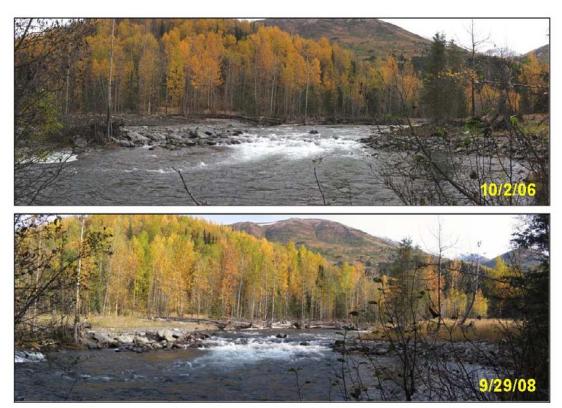
**Figure 4.23**: Resurrection Creek Photo Point 27 (panorama), showing the lower riffle of Meander 5. Although this riffle is one of the steepest in the project reach, no headcutting is evident in the 2 years since project completion.

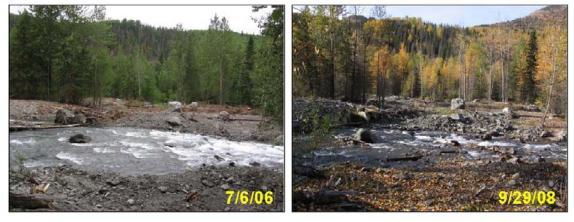
**Figure 4.26**: Resurrection Creek Photo Point 31, showing the steep riffle of Palmer Creek where it joins the Resurrection Creek floodplain. This steep riffle has shown a small amount of adjustment over the 2 years since project completion.

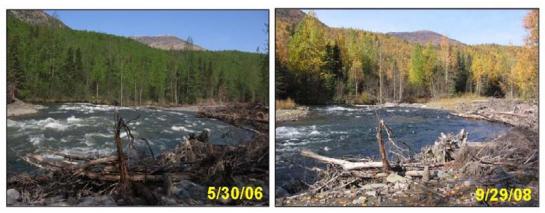
**Figure 4.33**: Resurrection Creek Photo Point 45, showing the lower riffle and logjam of Meander 5. Few major channel changes have occurred at this location.

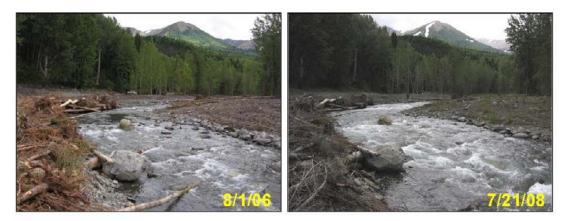
**Figure 4.35**: Resurrection Creek Photo Point 50, showing the lower riffle of Palmer Creek, just upstream of the confluence. Few channel changes have occurred. Revegetation in this area has been slow because of the compacted, clay-rich soils spread following restoration.

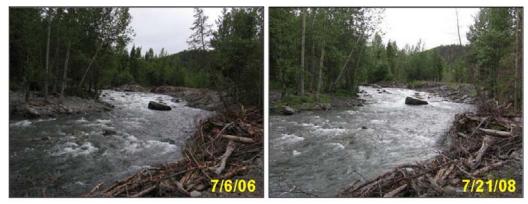
**Figure 4.36**: Resurrection Creek Photo Point 51, showing the steep riffle of Palmer Creek where it drops onto the Resurrection Creek floodplain. It is expected that some future adjustments in slope are occurring and will continue to occur at this riffle because of the steep gradient of the riffle.
